CCH8™ Bulk Rolls

Lephalale, South Africa

CCH8™ was used to remediate a gravity thickener tank floor to extend its operational life and ensure efficient functioning at a mine in South Africa.

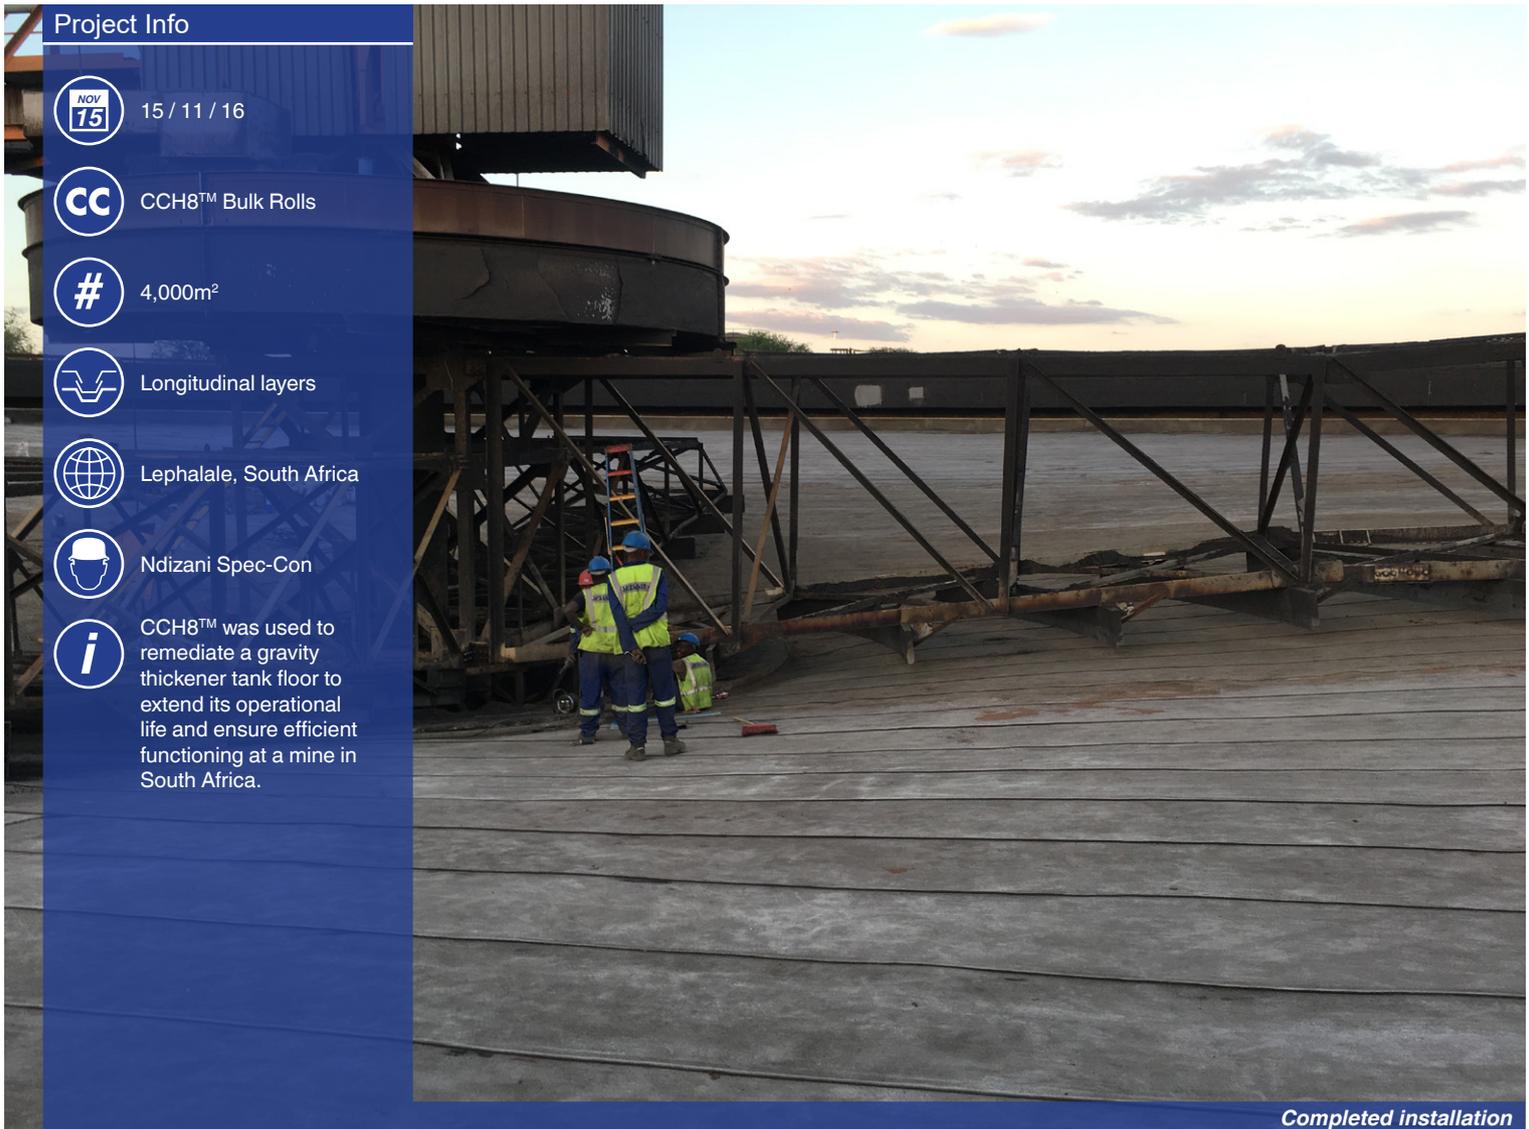
Completed installation

In November 2016, CC Hydro™ was used to line a gravity thickener tank floor at Exxaro's Grootegeluk mine in Lephalale, South Africa.

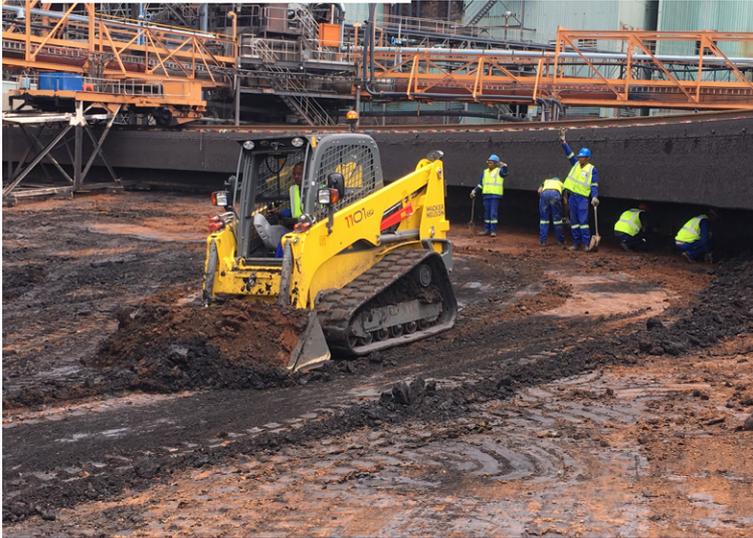
The tank was drawn down and sediment removed before installation

Within the 3-week maintenance period the tank has to be drawn down, sediment removed and the current gravel wearing course re-graded and compacted prior to any lining. However, the timeframe allocated to the installation of CCH8™ was just 7 days due to the limited time remaining in the program after completion of other items.

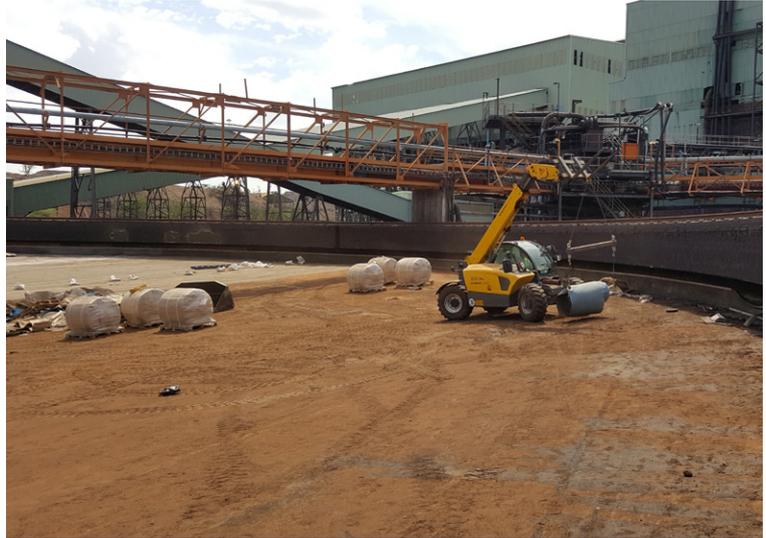
The CCH was delivered to site in bulk rolls

Once the ground preparation had been completed, the CCH8™ was delivered to site in bulk rolls. These rolls were then lifted into the tank and manipulated on site in accordance with stringent occupational health and safety standards. Once unrolled and positioned, thermal welding of the geomembrane was conducted and the welds pressure tested. Once welding was completed, the CC Hydro™ was hydrated.

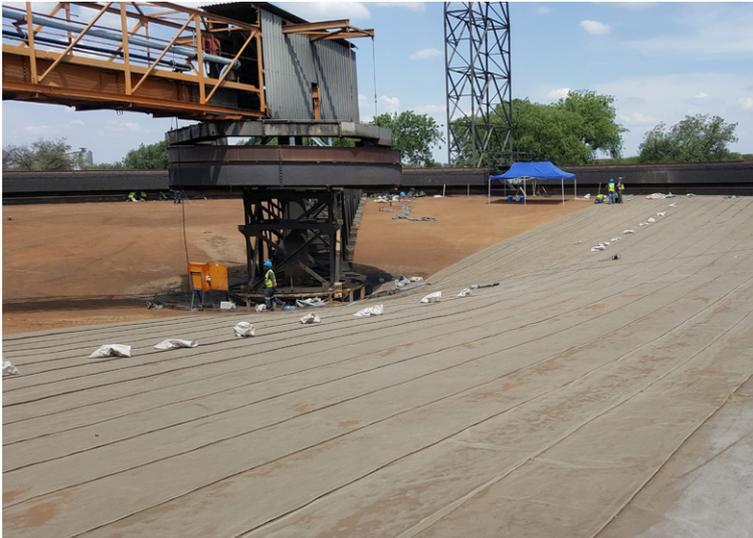
The CCH was installed over 7 days

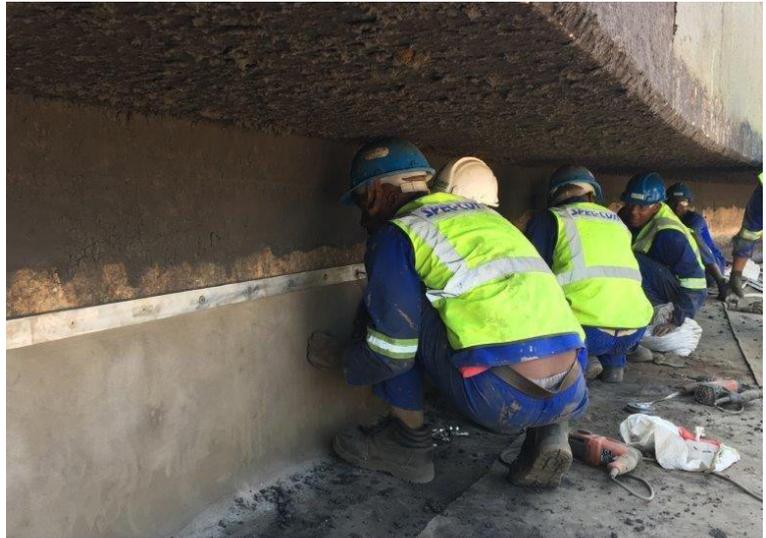
Fixing the CCH to the tank walls

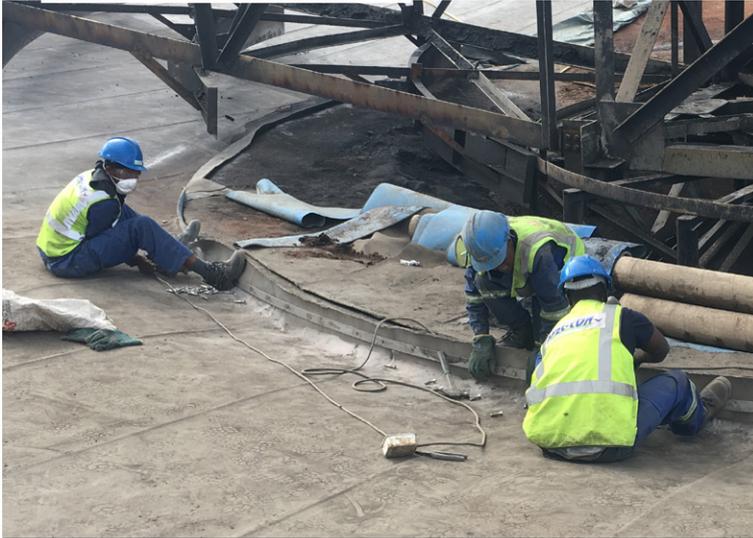
The flexible CC was easily fitted to the complex shape of the tank

The client was satisfied with the outcome of the installation, and impressed with how easily CC Hydro™ could be cut to fit the tank without any kinking or rippling. The tank is once again operational.

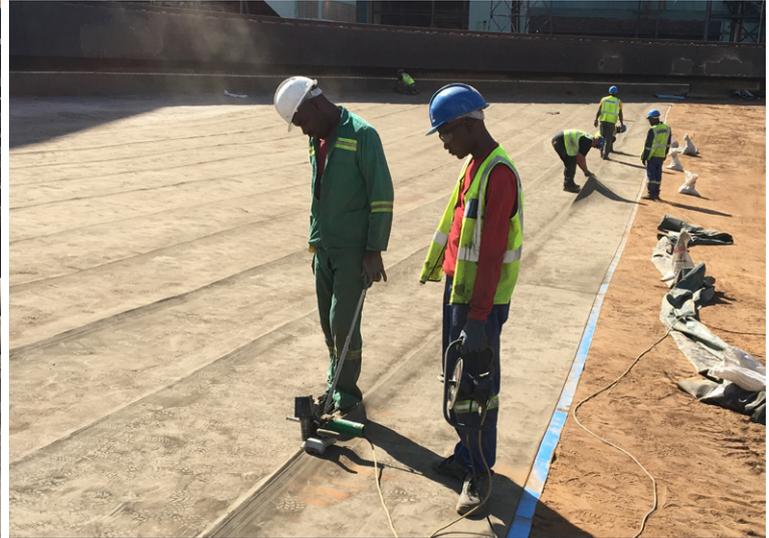
Thermal welding

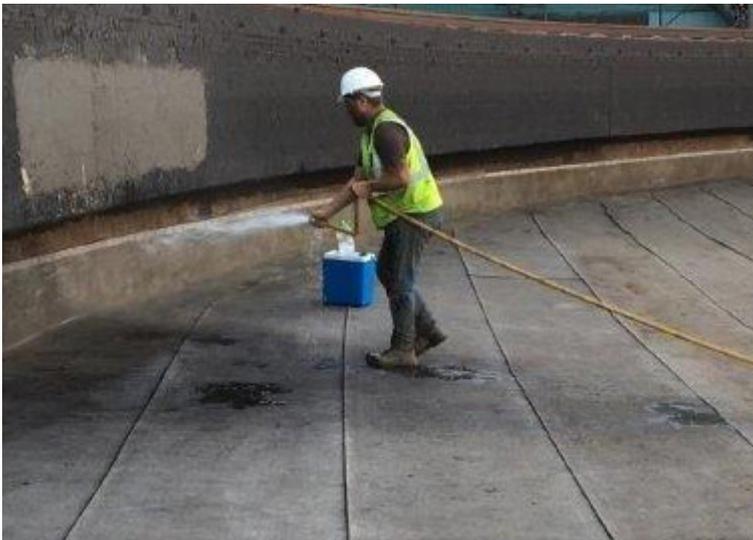
Hydration of the CC Hydro™

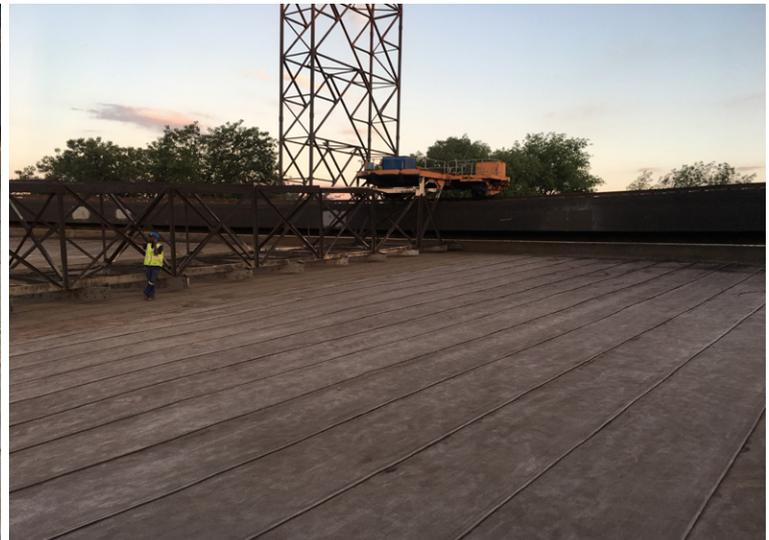
Completed installation

In total, around 4,000m² of CCH8™ was laid within the allocated 7 days without any interruption.
