## Project Info

**CC** CCH8™ Bulk Rolls

**G** St Quentin Zoo, Aisne Department, France

**i** CCH8™ was used to line newly constructed ponds in bird and mammal enclosures in St Quentin Zoo, France

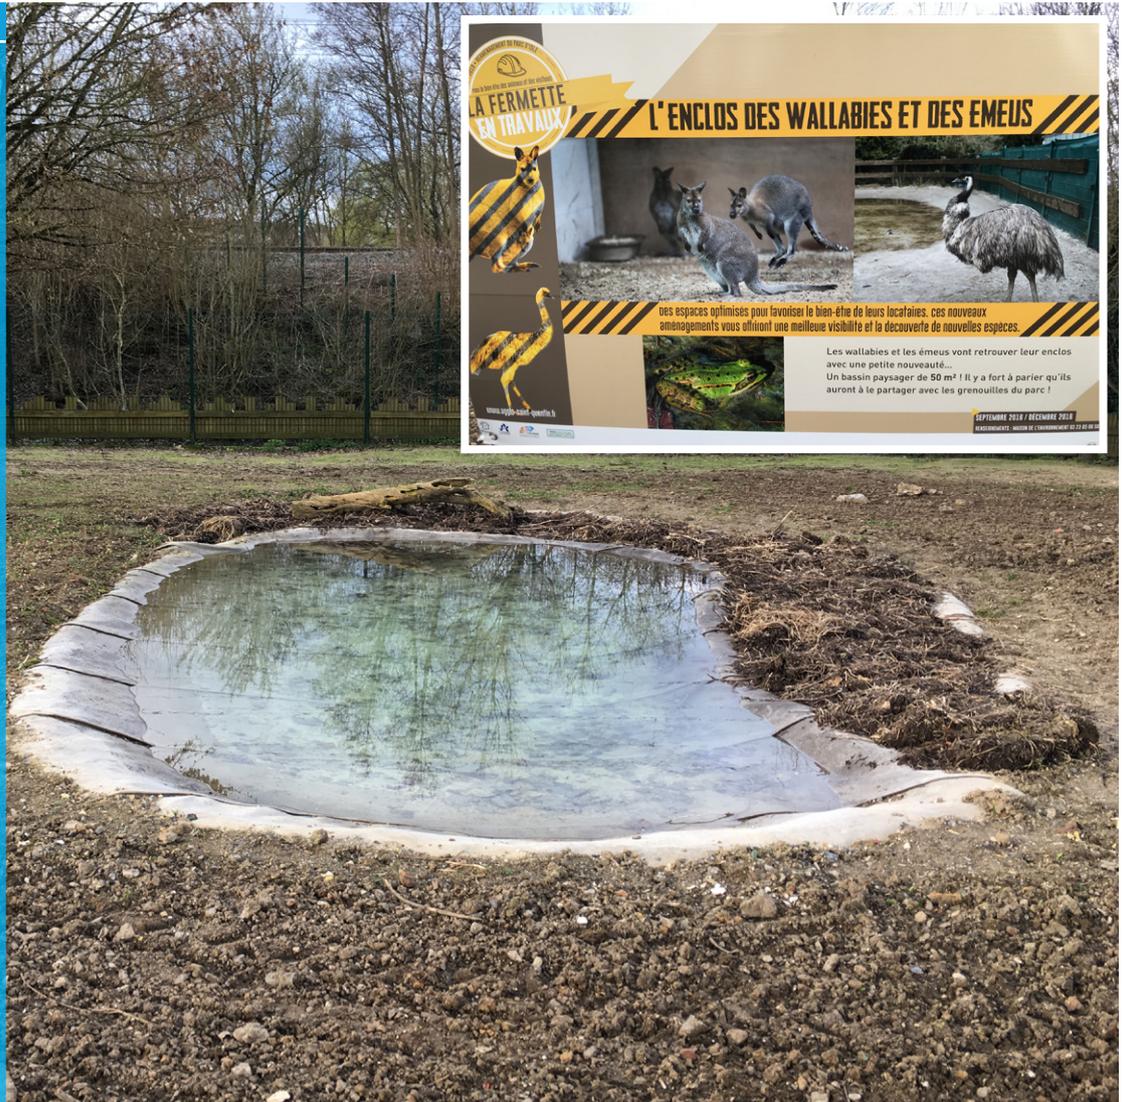
A finished pond at St Quentin Zoo

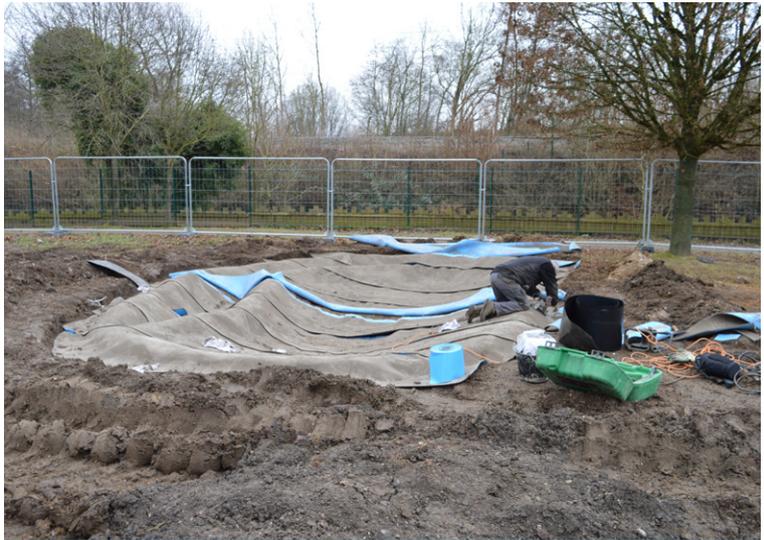
The CCH was laid transversely across the ponds

Once the ground preparation was complete the CCH material was delivered to the site in bulk rolls of CCH8™, which was mounted onto a spreader beam and digger, and unrolled transversely across the width of the ponds. The CCH layers thermally welded using Leister Twinny T and Triac welding equipment and the edges of the CCH material was secured in the anchor trenches using ground pegs. The CCH material was hydrated and the anchor trenches backfilled. This process was repeated for each of the ponds.

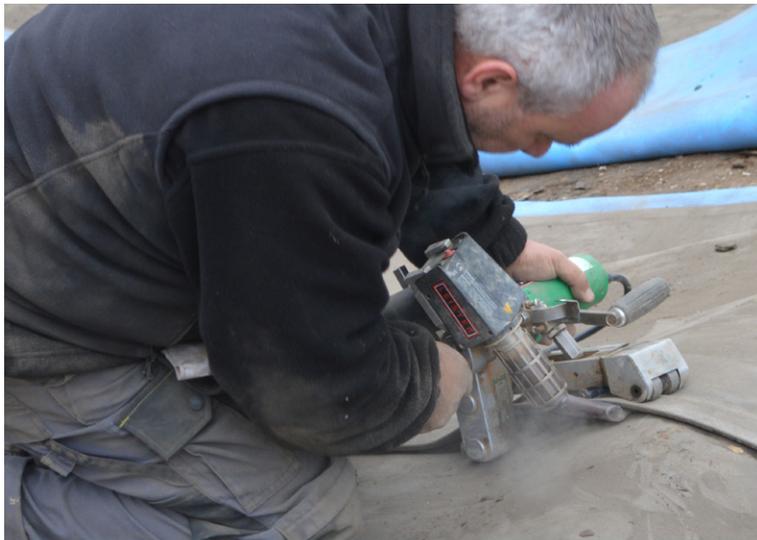
Thermal welding on the CCH joints

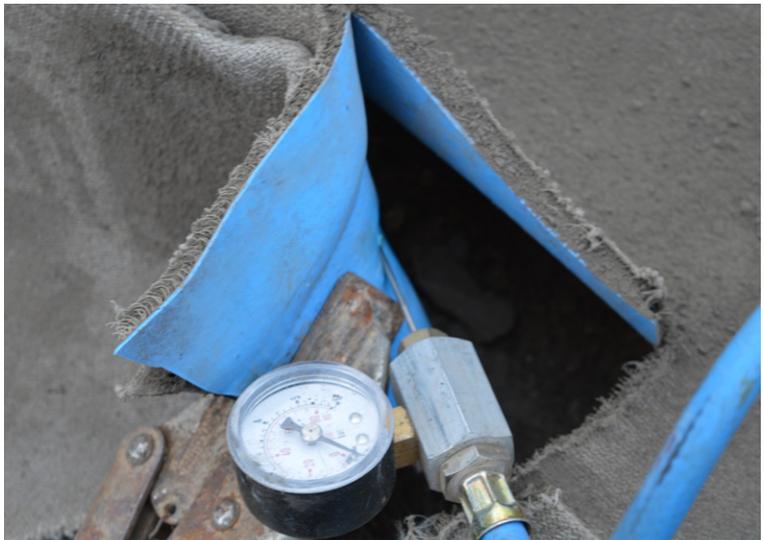
Pressure testing of the welded joints

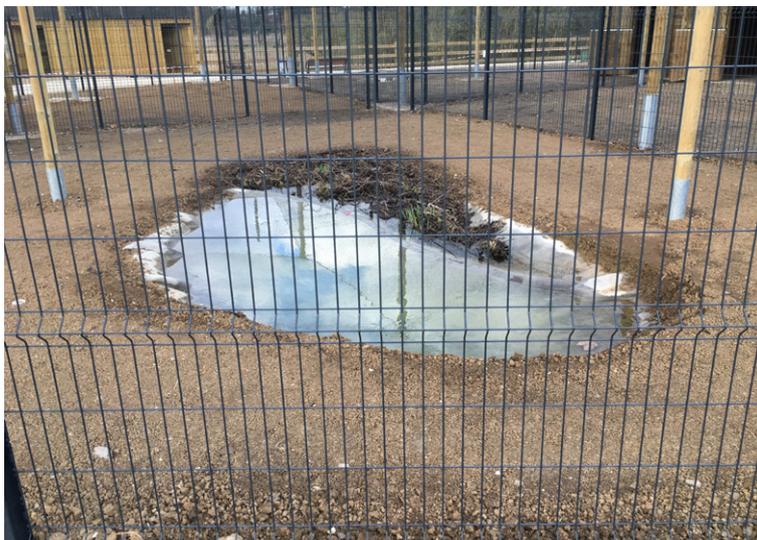
A completed pond
